PU grouting in cold environment at fully operating Fljótsdalur Powerplant

Jóhann Örn Friðsteinsson (jof@verkis.is)

Verkís hf, Reykjavík, Iceland

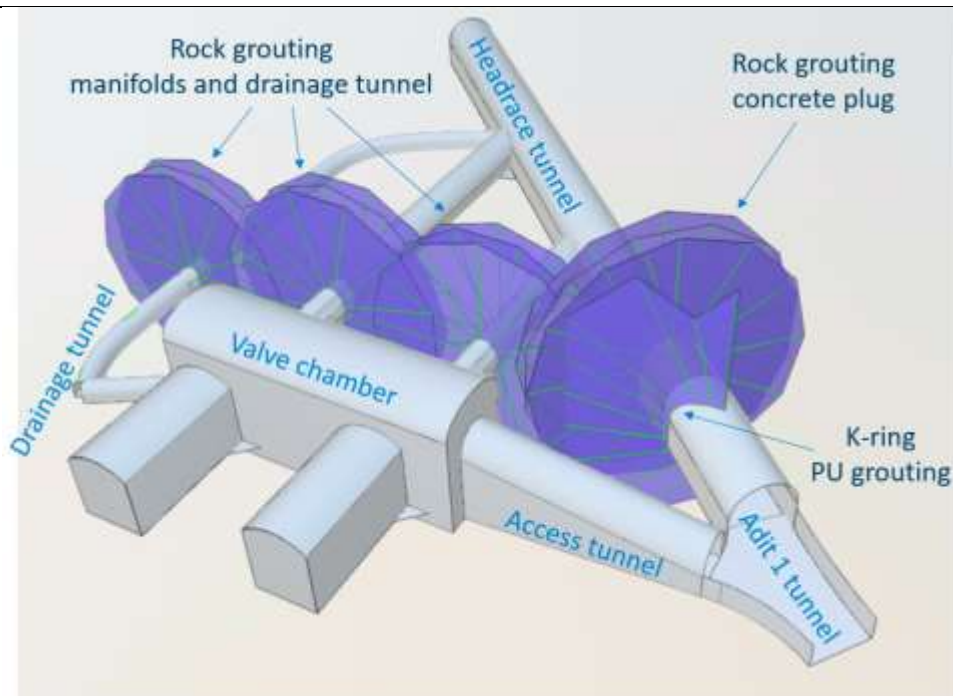
During pressurization of the headrace tunnel in 2007, there was a significant leakage from the Headrace tunnel into the valve chamber, to the main extent into the access tunnel. Additional grouting curtain with polyurethane (K-ring in Figure 2)) was performed in 2008 to seal off the inflow, when 8.500 liters of polyurethane was injected into the rock mass, and PVC membrane was placed on rock walls for protection of electrical equipment in the valve chamber and the access tunnel. The total leakage through the valve chamber after the grouting in 2008 was approximately 10 l/sec.

Figure 2. Layout in the valve chamber area and location of additional grouting curtain from 2008 (K-ring).

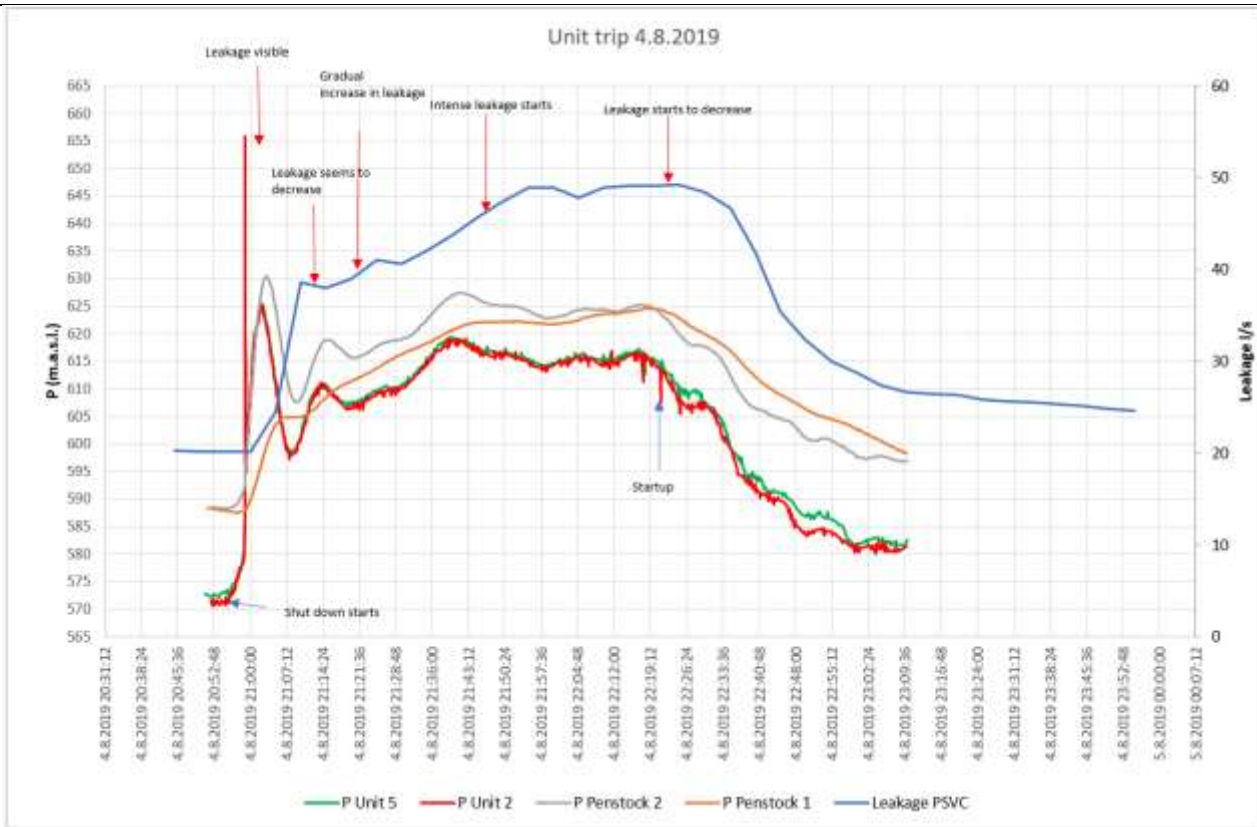
Figure 3 shows records from the monitoring system and reflect the transient state in the waterway during water hammering pressure pulses and associated increased in leakage measured by the measuring weir. Pressure gauges installed at the top of the penstock are representative for the state in the pressurized headrace tunnel. Review of the data from the monitoring system and video records show that the leakage comes in three pulses where the top of the first pulse is measured 4-6 minutes after the first pressure peak in the penstocks, which then increases by up to 40 m (mH₂O) during the episodes. The effects of the initial water hammer seems not to affect the leakage due to the short time that such a high pressure is occurring in the system. Considering 4-6 min delay in response time, leakage seems to start to increase when pressure in the penstock and headrace tunnel reaches roughly 20 mH₂O above normal state.

Figure 3. Graph showing water pressure at units and penstocks and during unit trip 4. august 2019 and recorded leakage from PSVC. Text above graph with observation on video records.

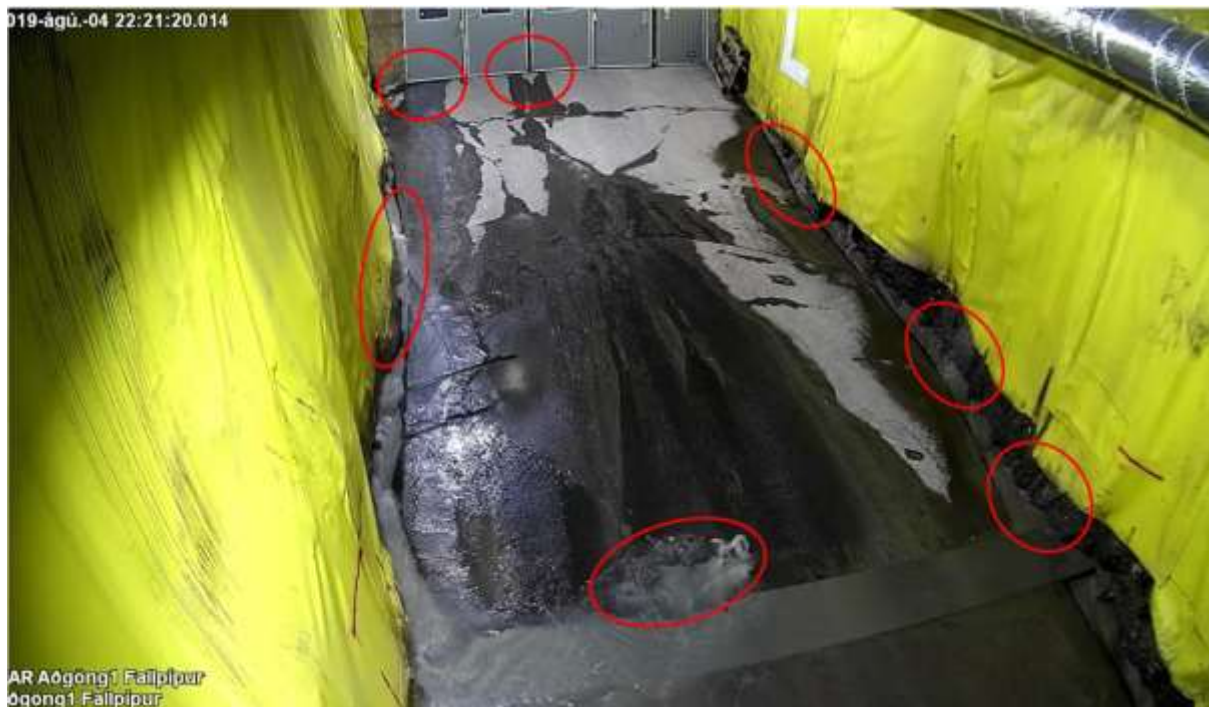
Review of records from CCTV cameras in the valve chamber show clearly that the leakage increases in both sides of the access tunnel as well as up through the center of the concrete invert. Leakage is also observed coming from the junction in adit 1 tunnel, under the portal between the access tunnel and the adit tunnel (Figure 4).

Figure 4. Observed increased leakage in access tunnel during a unit trip in august 2019. Note water flowing under portal door.

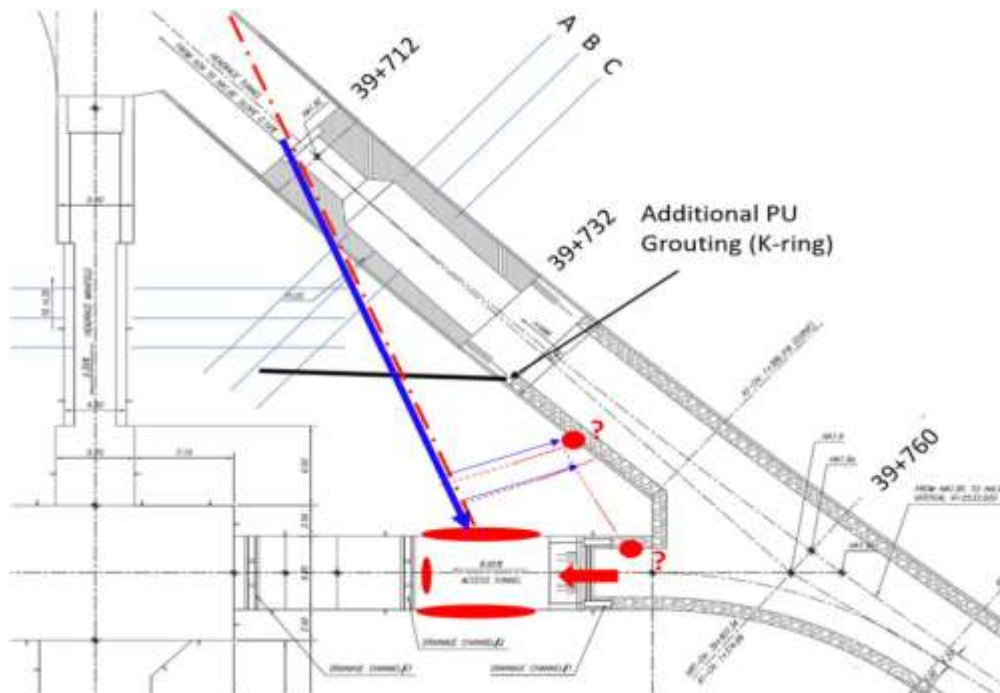
Study of as build documents and geological mapping from the construction time indicate that water is flowing through similar pathways as prior to the grouting of the K-ring, and the water is being transferred by joint sets and fracture zone orientated diagonal to the tunnel system. It was though uncertain if the water was flowing above or under the grouting curtains or even through them. Field investigations showed also signs of increased leakage during unit trips in the adit 1 tunnel. Orientation of possible leakage ways is shown in Figure 5.

Figure 5. Possible flow pathway (blue) from the headrace tunnel to the access tunnel and adit tunnel. Note possible leakage areas with question marks in the adit tunnel outside the access tunnel to valve chamber.

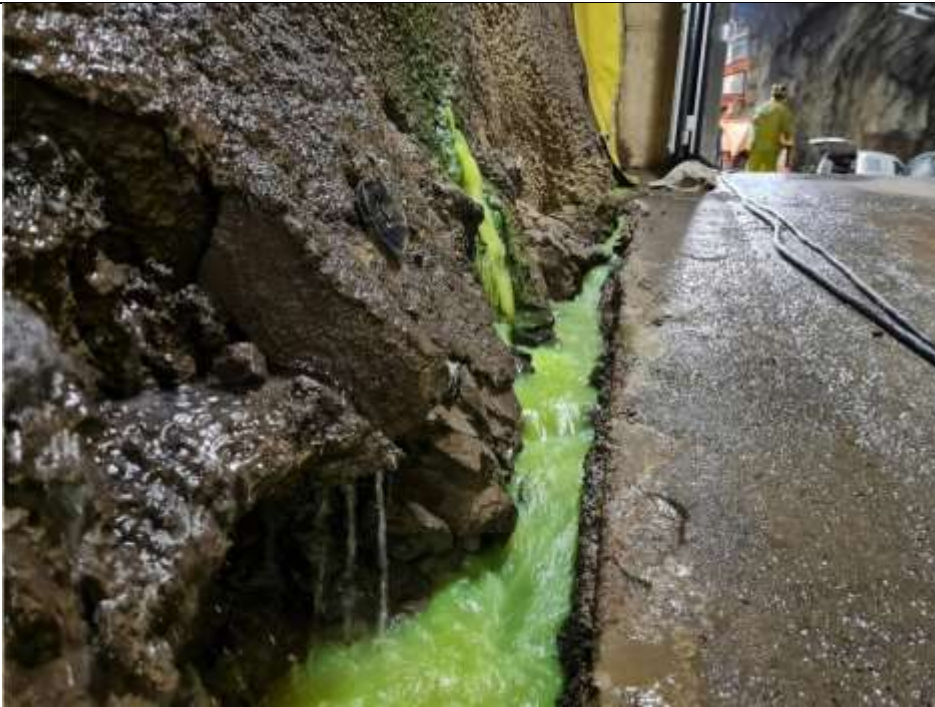
Figure 6. Clear connection between probe hole and leakage in the access tunnel during permeability test.

Permeability tests with Fluorescein sodium blended into the injected water showed that the response time, from pumping until the colored water appeared in the access tunnel, was ranging between 9-15 minutes (*Figure 6*).

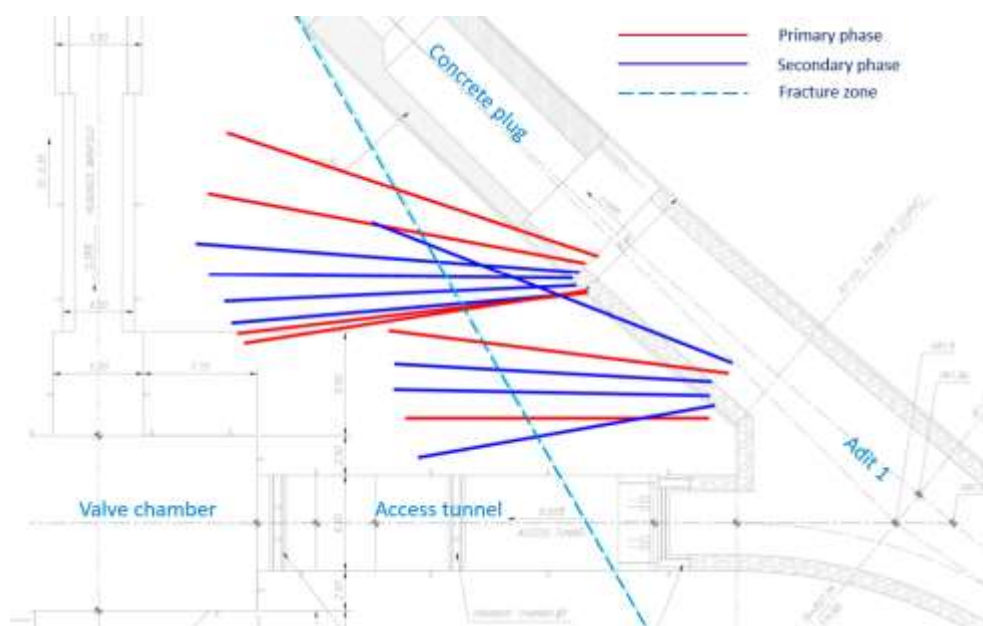
Figure 7. Original plan for grouting with primary (red) and secondary (blue) phase, location of potential fracture zone along dashed line.

In the original design it was planned to use the drill holes from the investigations in March as primary holes for grouting, and after completion of the grouting to drill secondary holes by forming a double array umbrella in the rock pillar between the headrace tunnel and the valve chamber (*Figure 7*). All primary and secondary holes were drilled to the minimum 24 m depth. Penetration rate and colour of flush water was registered to map in more detail the geology of the rock mass and permeability tests were performed with colored tracer material in all holes.

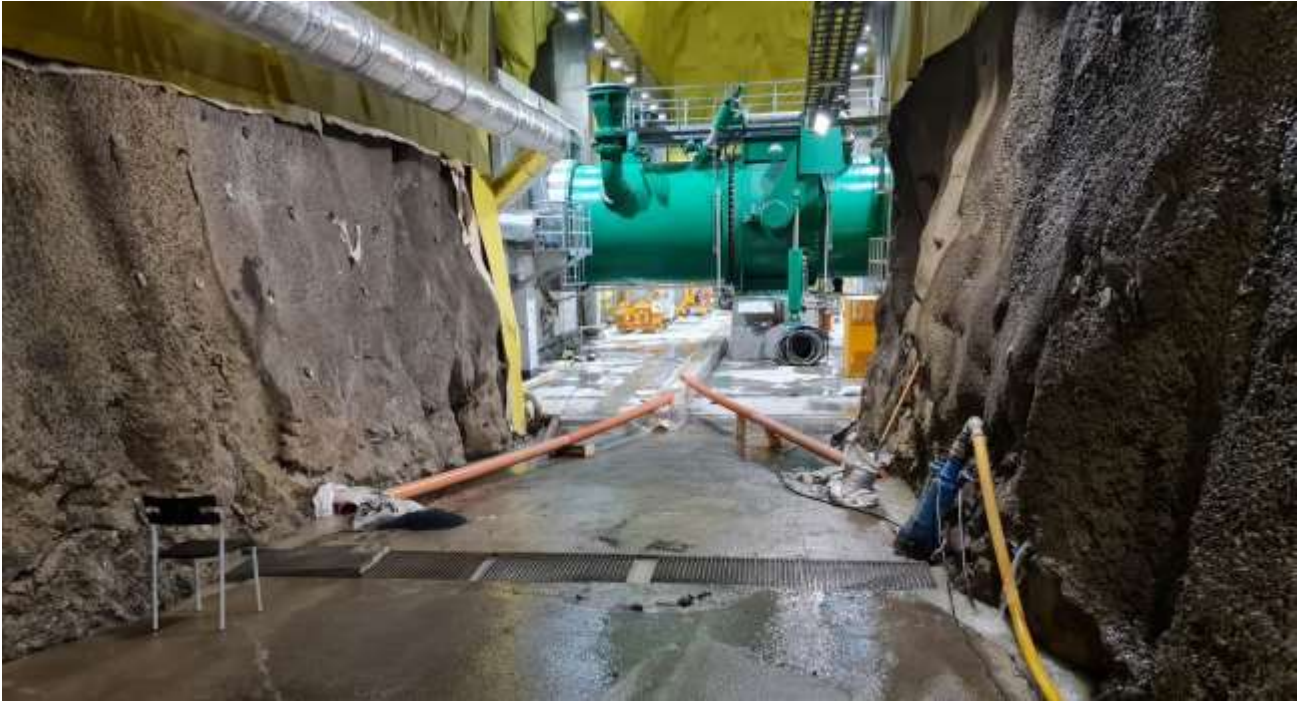
Figure 8. Provisional drainage system constructed on surface with open channel towards drainage tunnel to protect the permanent drainage system in the cavern.

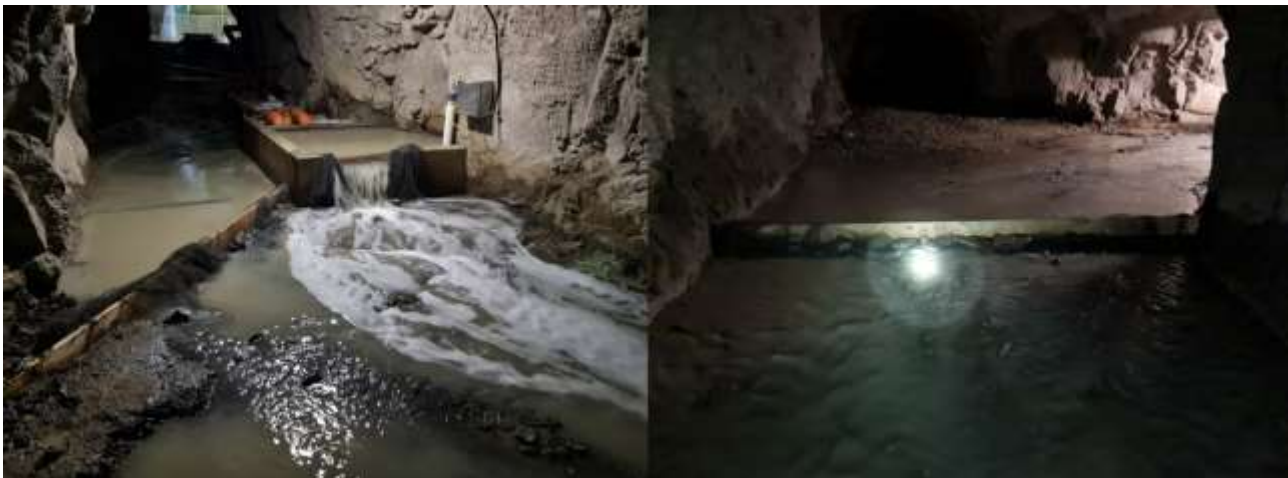
Figure 9. Measuring weir (left) and drainage tunnel invert installed with fishing net and wooden planks to catch reacted PU downstream the valve chamber.

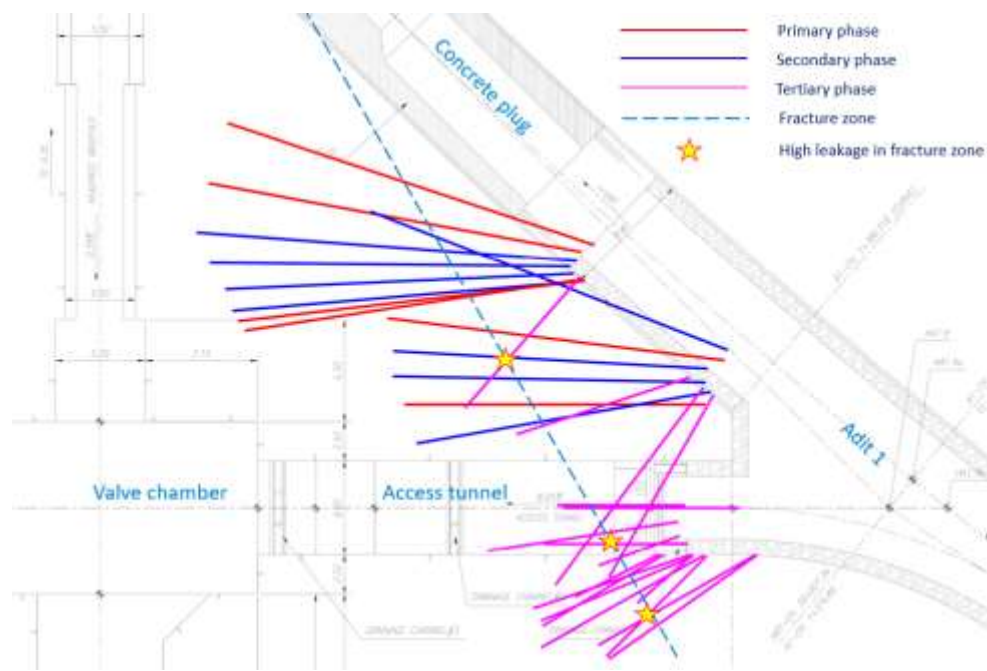
Result from drilling and permeability testing of the primary and secondary holes showed that the water was clearly flowing through a subvertical fracture zone crossing diagonal through the rock pillar, now mainly below the invert. The highest change of completing the task was thereby to search for the water bearing part of the zone and grout directly in the main water source. By drilling directly into the water bearing zone, a leakage of 180-200 l/min with water pressure of up to 15 bars was measured. Grouting into this fracture zone was highly complicated as the leakage of this magnitude caused unreacted PU to flow out of the joints in the access tunnel and the polyurethane did not start to react until it was through the pillar and settling on the invert. The result of using higher foaming factor, adding accelerator or use thicker mixture resulted either in clogging of the holes or the water found new pathway through the fracture zone and into the tunnel. A unit trip occurring in the middle of the grouting process also gave leading information as now one could see which areas were tight and which were responding to the transient state in the headrace tunnel. As the result, it was decided to drill and grout umbrellas between the highly leaking zones and the periphery of the access tunnel where the water was leaking out, in the attempt to make a barrier closer to the tunnel and slowing the flowing rate through the rock mass before attacking the main water-bearing areas. After a reasonable tightness was accomplished, two additional holes were drilled in the main vein and packer with a valve was placed in one hole to control the water pressure and flow rate in the fracture zone while the other one was being grouted. This procedure proved to be successful and stopped the main leakage in the access tunnel. Location of grouted holes from all phases are shown in *Figure 10*.

Figure 10. Final layout of grouting holes after all three phases. Tertiary phase with unregular pattern after chasing new pathways in the bedrock, mainly below the invert.

Seventeen holes were drilled and grouted in this tertiary phase of the grouting work and roughly 8000 liters of PU was injected, thereof 3000 liters in the main fracture zone. The total leakage measured at the measuring weir had at this point decreased down to 4 l/sec, the main leakage mainly coming from the 1 km long Adit 1 tunnel. The grouting work was finished 24th of November.

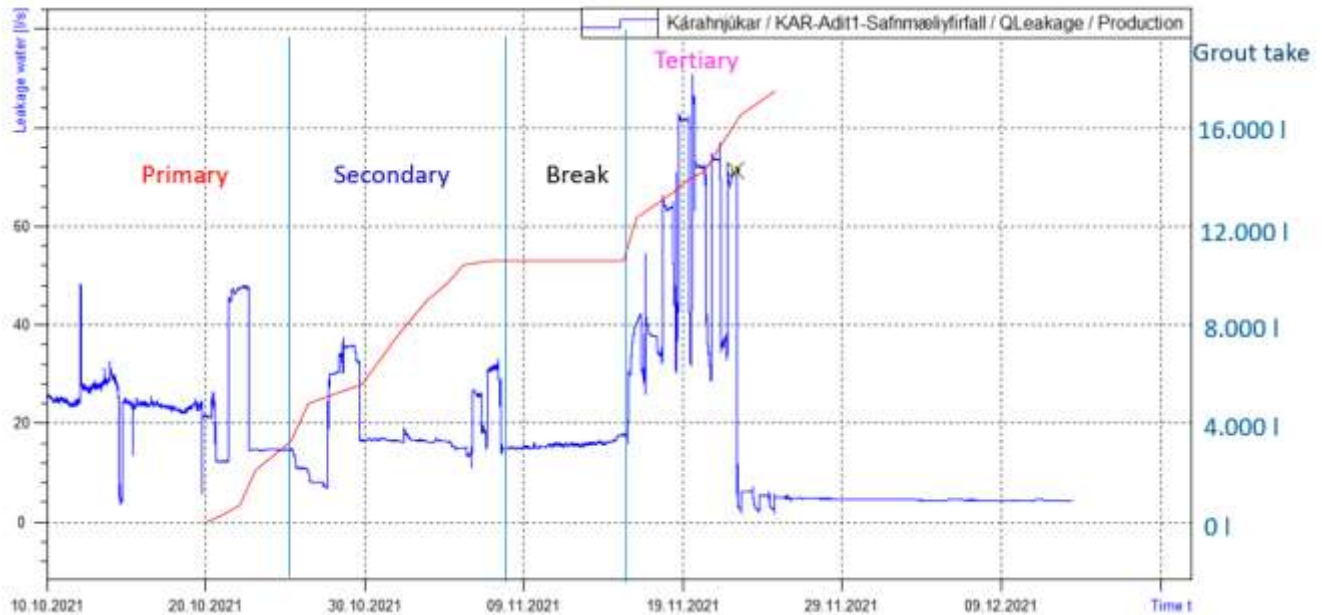
Figure 11. Total amount of leakage water from measuring weir (blue) and accumulated grout take (red) during grouting work. Irregularities due to preventive measures in the measuring weir (see Figure 9).
