Extreme Challenges in Vadlaheidi Road Tunnel Case History

*Oddur Sigurðsson (osha@vegagerdin.is)
Icelandic Road and Coastal Administration*

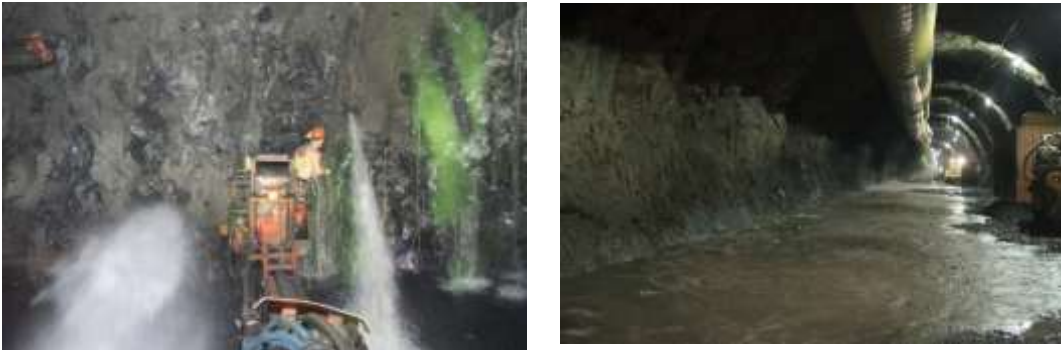
Tunnel excavation from the West side started on July 3rd, 2013. On February 15th, 2014, a large inflow of 46°C hot water, approximately 350 l/s, occurred. The total length of the tunnel was at that time 1870 m. The excavation was continued with very frequent grouting operations, increasing water temperature and rapidly decreasing working conditions. It was therefore decided to post grout the area. The grouting work was executed in June and July of 2014. Although a relatively successful post-grouting operation the working conditions were extreme due to water and rock temperature up to around 63°C. Late

Figure 2. Inflow of 46°C hot water, total of 350 l/s.

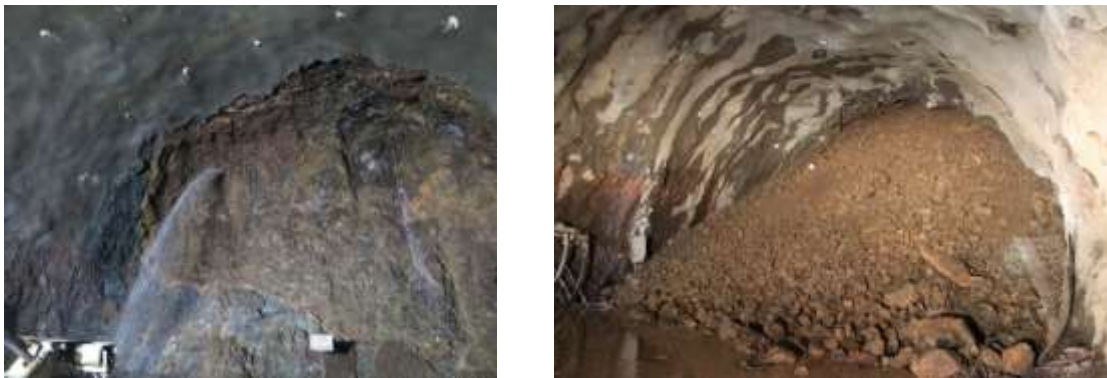
Tunnel excavation from the East side started on September 5th, 2014. After relatively successful tunnel excavation work, an extreme collapse occurred on April 17th, 2015, from a 10 m wide fault zone. The tunnel length was at that time 1475 m.

Figure 3. Collapse in the tunnel

Shortly after the collapse, an inflow of 7°C cold water of up to 518 l/s followed. The tunnel was filled with water and tunnel excavation consequently stopped.

Pumping of water from the tunnel started in October 2015 and preparation work for continuing tunnel excavation started in January 2016. After successful grouting and consolidation grouting work, as well as very heavy reinforcement of the roof part, using a pipe umbrella, to excavate through the fault zone, tunnel excavation commenced on the East side on October 19th, 2016 and break-through was obtained on April 28th, 2017.
